ANTIETAM DAM

INVENTORY NUMBER NDS PA-332

PHASE I INSPECTION REPORT

SEPTEMBER 1978

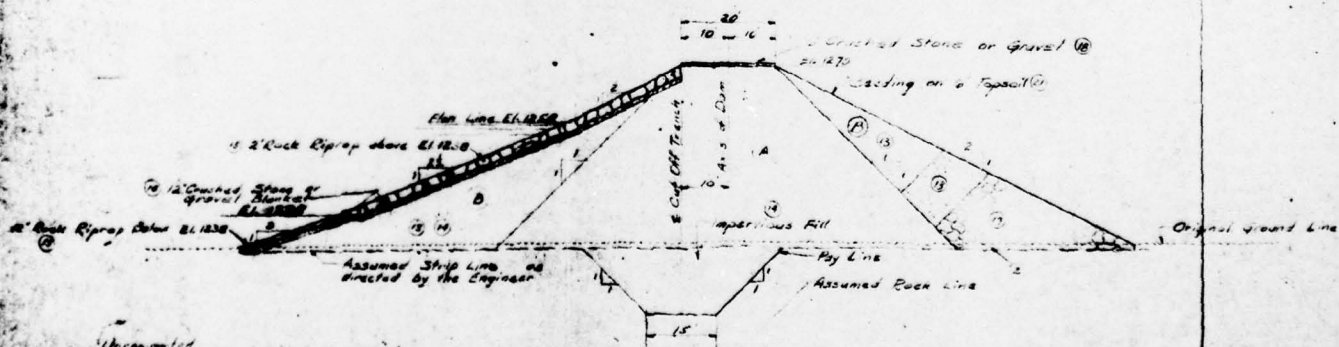
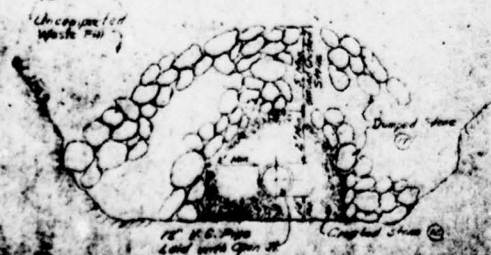
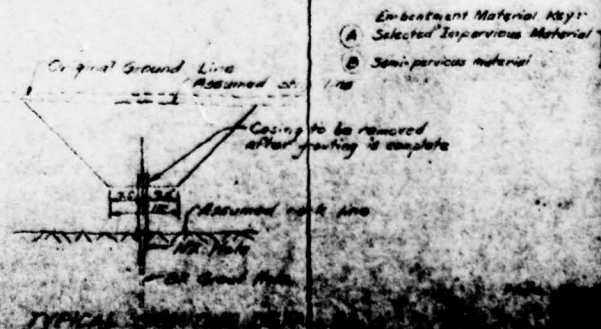
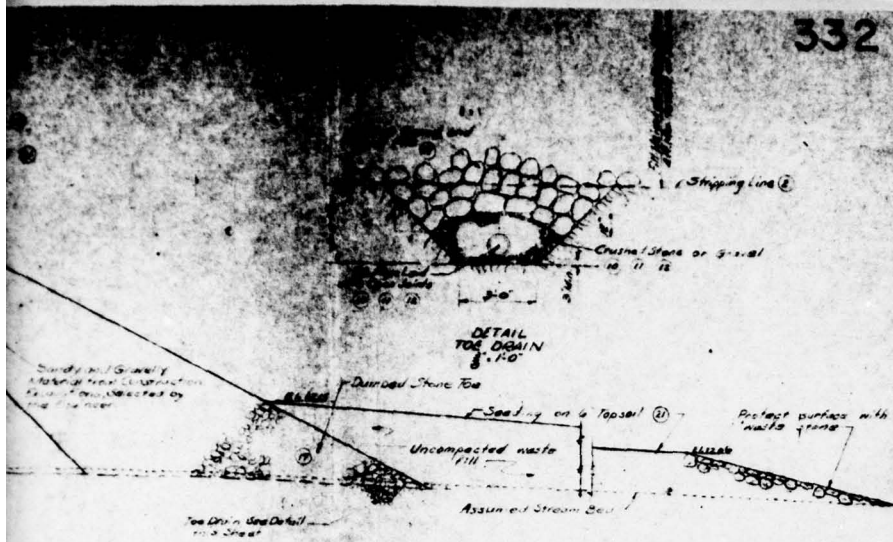
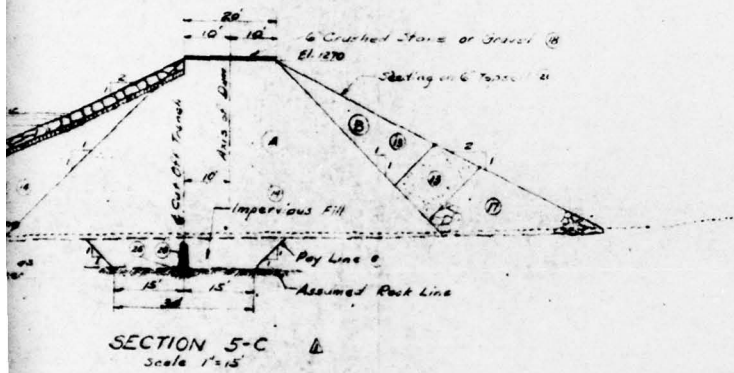
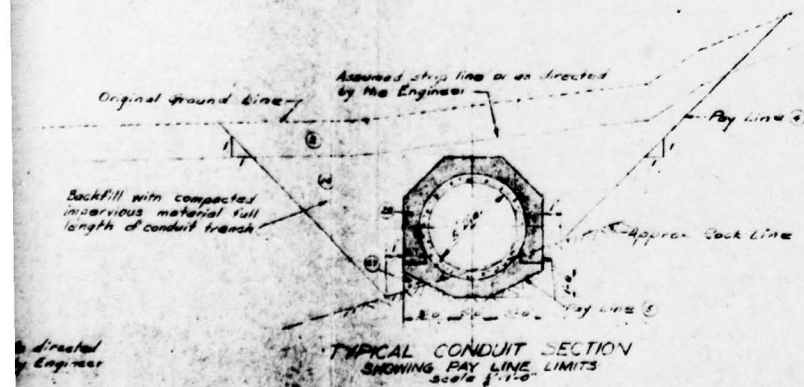
PLATE VII

A cutoff trench is provided and is filled with impervious earth. Drilling and pressure grouting was carried out in the underlying foundation rock formations. Refer to Appendix D, Plate VII.
